Wearing Surface Testing and Screening: Yukon River Bridge

FINAL REPORT

Date: September 2015

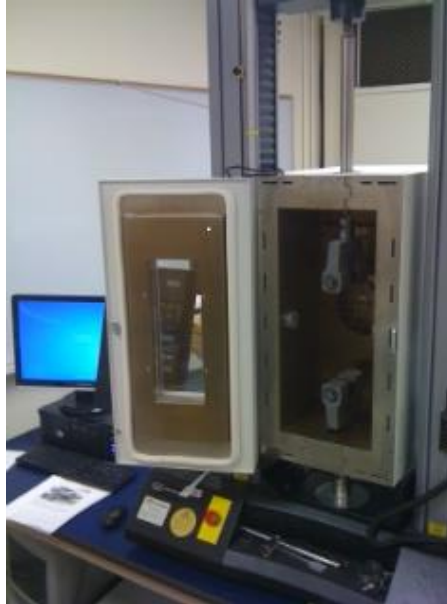
Figure 17: Instron tensile test apparatus.

- Tensile Test
 - Allows the ability to measure bond strength with a variety of different materials.

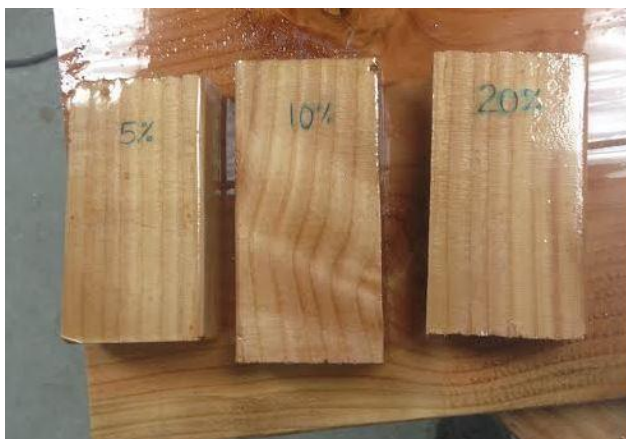
Figure 19: Test samples 3–5%, 10%, 20% isopropyl alcohol.

In order to test the resistance to moisture migration vs. percent alcohol in an epoxy mix, three different test boards were made. To determine what percent of isopropyl alcohol gave the best results, different percentages of it were added to the Type III dot epoxy. These sample board tests were conducted using the following procedure:

4. After mixing the epoxy and hardener homogeneously, added the desired amount of isopropyl alcohol. Mixed for an additional 2 min.
5. Once the mixture was well mixed, applied it to the sample board on all sides of the board. Application for this process was done using a ½ in. paintbrush.

6. Repeated Steps 4 and 5 for the other isopropyl alcohol mixes.
7. Once the board was completely covered in the alcohol/epoxy mixture, set it to dry for at least 6 hr.

3.7.1 Determining percent isopropyl alcohol (Figure 19)

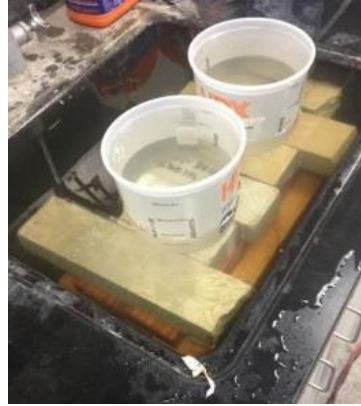
Figure 21: Test samples: no sealing, 1 sealing, 2 sealings, and 3 sealings submerged in water.

10. Boards were then placed under water in a large container.
11. On days 1, 2, 3, 7, 14, 20, 26, and 117 of being submerged in water, the weights were retaken to determine the amount of water each board absorbed. (This was done using a digital scale. Each board was weighed 3 times to ensure accurate results, and the average was then taken for each board).

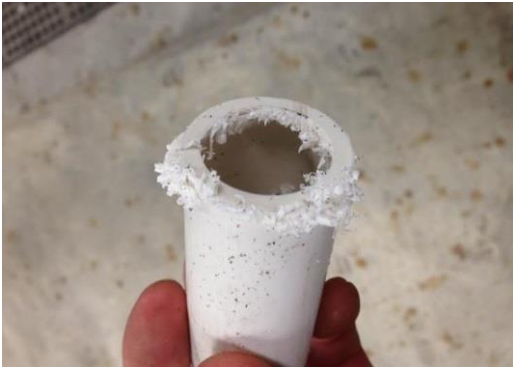
Figure 31: Bur on PVC pipe

6. Inspect the holes looking for any slivers; remove with pliers or sandpaper.
7. Sand the surface of the boards.
8. Tack the boards with tacking cloth, to get rid of the impurities and loose wood dust.
9. Cut 1½ in. PVC pipe to 1-5/8 in. lengths. This length is determined by the depth of the countersunk holes plus the thickness of the aggregate coating to meet the desired overall thickness of the planks.
10. De-bur the PVC cut pipe (Figures 31 and 32).

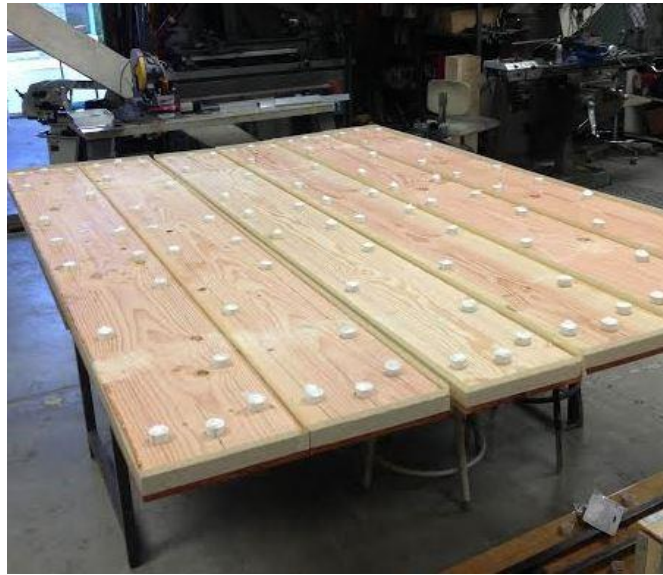
Figure 34. Plank preparation before aggregate application.

1. Be sure that the boards are completely dry and are not tacky.
2. Apply tape around the top perimeter of the boards to make up the overall thickness of the planks. This acts as a coating barrier. In this case, the boards were 1-7/8 in.; therefore, a 5/8 in. overhang of tape was applied to meet the overall height of the boards of 2½ in.
3. Place cut and de-burred PVC pipe into the countersunk holes of the planks.
4. Fill the inside of the PVC pipe with cotton balls to enable the coating to get inside the holes during the application process.
5. Lay out the planks on sawhorses to apply the coating (Figure 34).

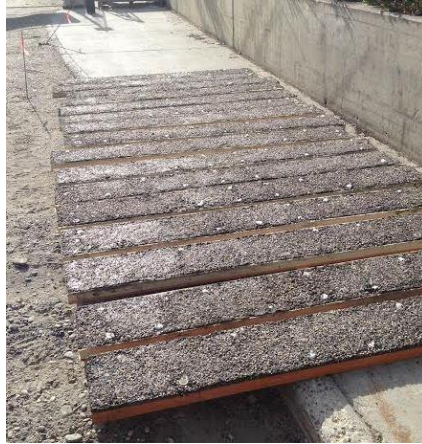
Figure 35: Planks drying.

13. Apply the mixture to the boards, using your hands to spread the epoxy as evenly as possible. Gauge the thickness of the aggregate coating by the height of the tape and the height of the PVC pipe sticking out of the countersunk holes. Be careful not to cover the tops of the countersunk holes.

14. Once the mixture is in place, liberally apply the local aggregate by broadcasting it across the top of the boards. The top of the boards should look like they are covered with evenly dispersed dry aggregate.
15. Allow the mixture to dry on a level surface for at least 6 hr (Figure 35).
